CAPITAL PLAN

FORT VERMILION SCHOOL DIVISION

**FORT VERMILION SCHOOL DIVISION
THREE YEAR CAPITAL PLAN
2024 – 2027**

FORT VERMILION SCHOOL DIVISION
SANDHILLS ELEMENTARY SCHOOL
10202 94 Ave, La Crête, AB T0H 2H0

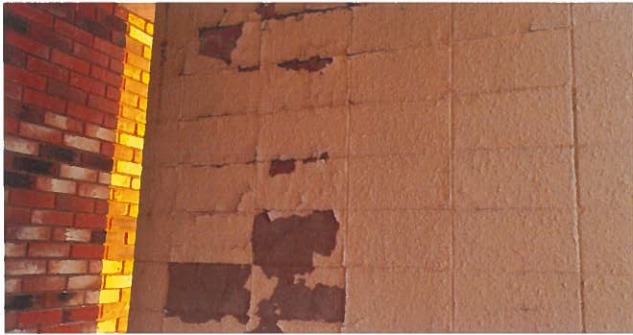
Spalling was noted on the exterior concrete block texture.

- Replace joint sealant.
- Replace portions of roofing as indicated.

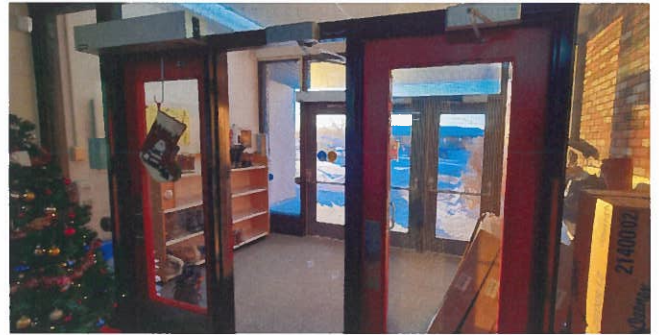
The main entrance of the school suffers from a lack of crush space that causes congestion for students, parents, and visitors.

There is a lack of crush space at the main entrance which causes congestion for students and parents.

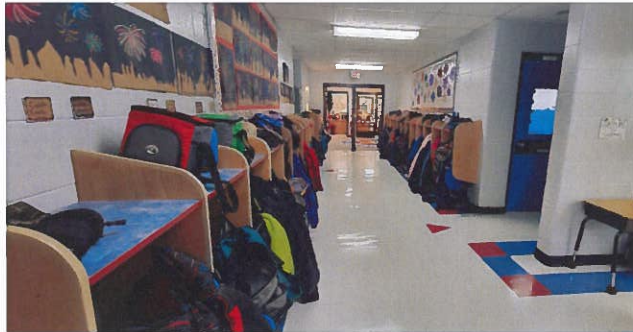
There is a lack of corridor space for cubbies and hooks.

Additional coat and hook space is needed throughout the school.

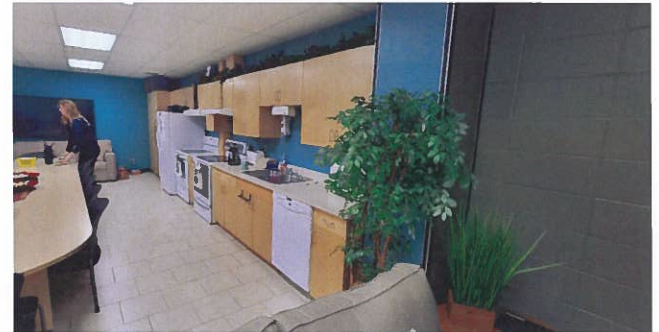
The staff room is undersized for the number of staff and is also used by parents as a kitchen space for preparing hot lunches.

A separate server area is required so that parents are not required to

use the staff room to prepare lunches.

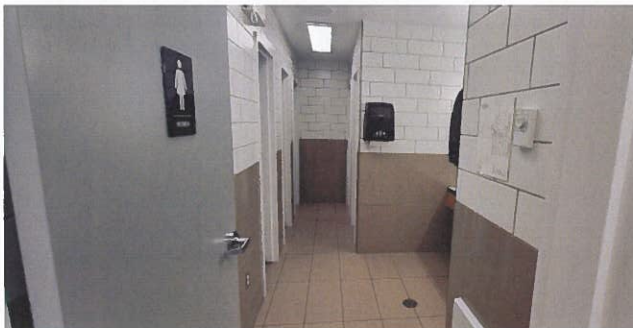
Staff washrooms have been expanded.

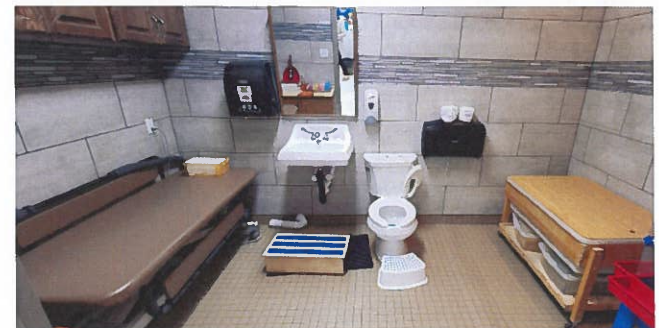
Due to the high number of students with complex needs, the universal washroom is fully scheduled.

The school has a high number of students with complex needs and the universal washroom requires a fully booked schedule with little flexibility.

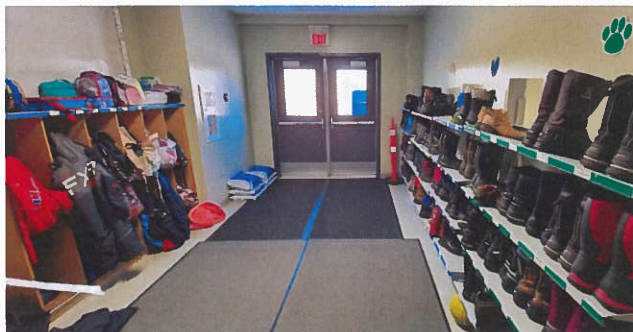
All vestibules are experiencing congestion.

3. **Circulation:** Vestibules are congested, specifically the link entrance for the modular classrooms.

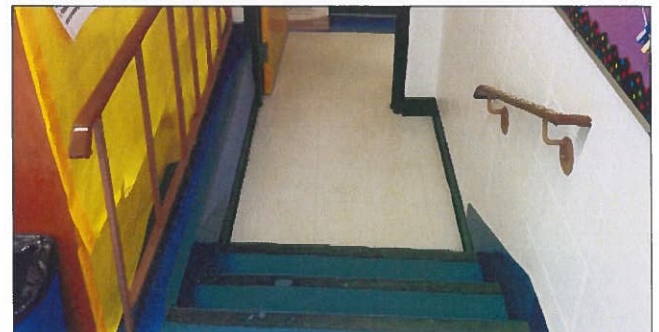
Accessibility to classroom 105 is an issue due to the space being the former stage.

Room 105 has a raised floor and stair access with no barrier-free accessibility.

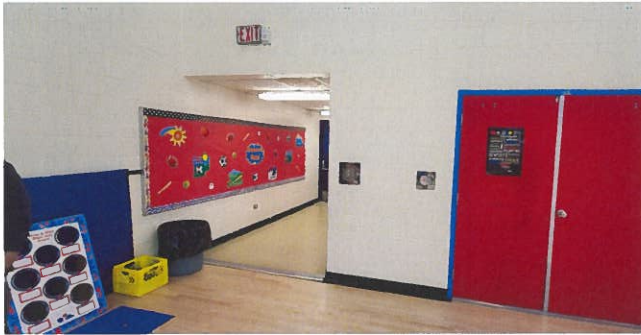
The single access point into the gymnasium causes congestion for students and community use.

- 6. Community Use:** It was noted that the lack of change rooms can be an issue for community use. The school also lacks adequate secure lock-off points to control community access to school spaces during after-hours use. Additionally, with only one access point into the gym, congestion is an issue.

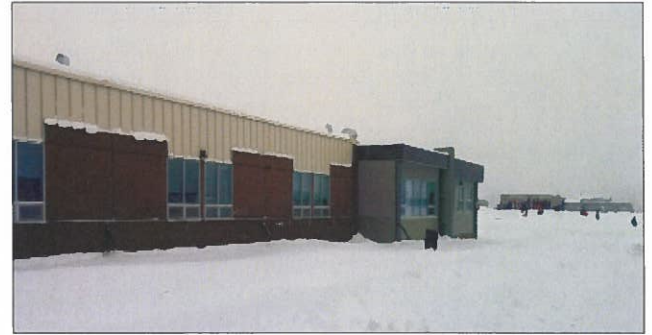
Supervision and lighting level is an issue on the North side of the modular classrooms.

- 2. Site Supervision:** Site supervision is an issue along the North side of the modular classrooms. Lighting also needs to be improved on both sides of the North modulares and at the staff parking area.

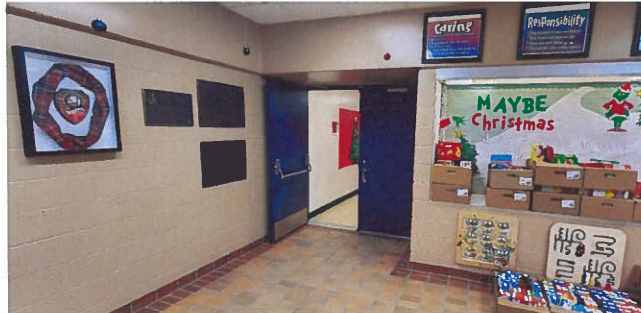
The single access point into the gymnasium causes congestion for students and community use.

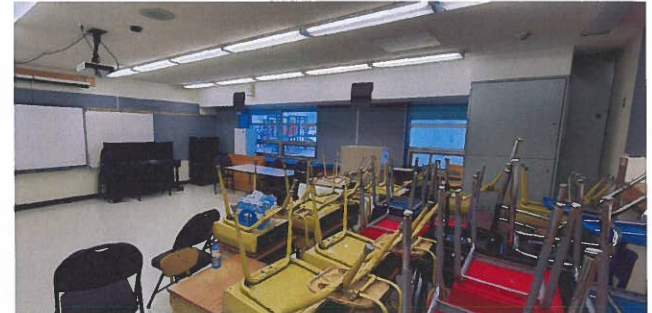
With a reduction in utilization, a number of classrooms are being used for sensory / pull out / meeting space / storage.

3. **Building Circulation:** It was noted that due to the configuration of the portable classrooms, the building is very spread out and the long distances impact instructional time. Due to low utilization, a number of classroom spaces are being used for sensory / pull out / and meeting space. The core of the school can be reconfigured into more effective collaboration space and unused portable classrooms can be removed to address travel distances and increase utilization.

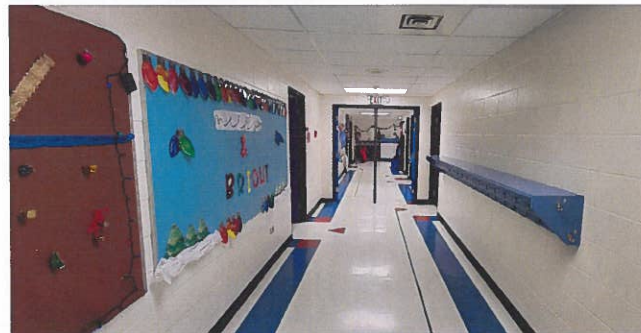
Previously, the lack of pull out spaces required that desks and teaching locations were in offices, the library, staff room, and corridors. With a reduced utilization, these activities take place in classrooms but with an increase in enrolment, this issue will reoccur.

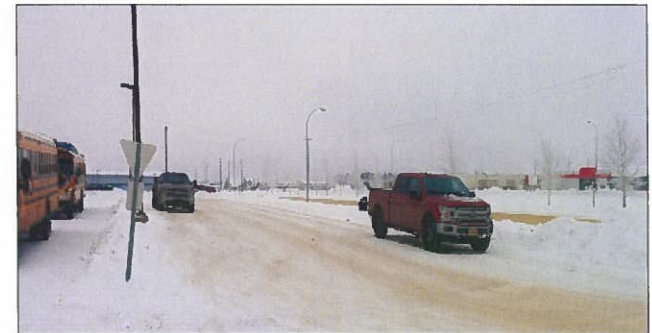
With the construction of the bus loop area to the North of the school, site congestion has been improved but a clear and dedicated drop-off is required to address parent traffic.

- 1. Site Circulation:** With the construction of the bus loop area to the North of the school, site congestion has been improved but a clear and dedicated drop-off is required to address parent traffic.

1. **Site Circulation:** A clear and dedicated student drop off lane is required to address parent traffic issues.
2. **Informal / Small Group Learning Spaces:** The central core of the school can be reconfigured to provide additional collaboration spaces. Two pull out spaces have been provided in the library but additional space is required. This would be accomplished by reconfiguring the existing Kindergarten, Classroom 138, and Library and creating an interconnected learning commons with associated break out spaces, small counselling areas, and alcoves where small group learning could take place.

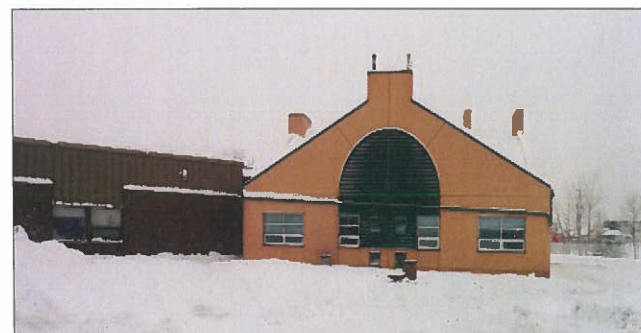
Pooling occurs on the site at the South moduls during spring thaw. Lighting levels should also be improved in this area.

- 3. Site Drainage:** There is pooling at the North and South modulares with ice at many of the entrances.
- 4. Informal / Small Group Learning Spaces:** There is a deficiency of dedicated break out and counselling spaces for smaller group work. Due to a lower utilization, classrooms are being used for pull out space.

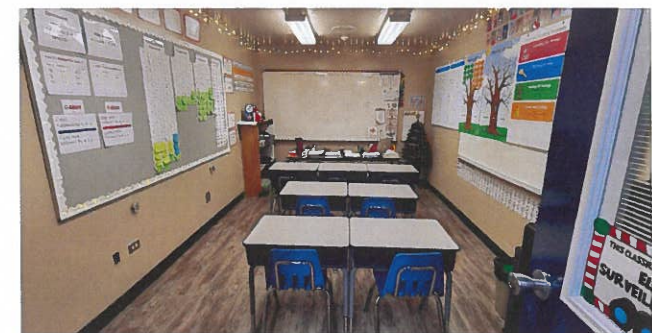
The school has a large central core of instructional spaces with no natural lighting or ventilation.

11. Natural Light / Ventilation: The planning of the school has a large central core of instructional spaces and the lack of natural light in these areas was noted. It was also noted that the classrooms along the South side of the school have small windows that have failed and are dirty between the glass panes.

6. **Natural Lighting:** The existing windows in the South classrooms could be replaced and enlarged to introduce additional natural light and ventilation.
