CAPITAL PLAN

FORT VERMILION SCHOOL DIVISION

**FORT VERMILION SCHOOL DIVISION
THREE YEAR CAPITAL PLAN
2023 – 2026**

FORT VERMILION SCHOOL DIVISION
FLORENCE MACDOUGALL COMMUNITY SCHOOL
10802 Rainbow Blvd, High Level, AB T0H 1Z0

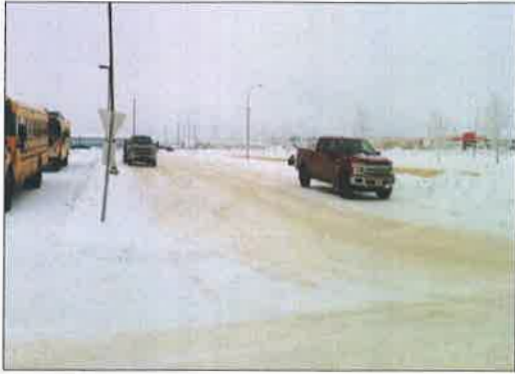
Student drop off is congested and a safety concern. The planned bus area and subsequent reconfiguration of the drop-off area will address this issue.

- 1. Site Circulation:** Bus circulation is acceptable but the student drop-off areas are congested and a safety concern. Parents will park in staff parking areas or students are dropped off on the front street and have to cross traffic to access the school.

- 1. Site Circulation:** The largest issue of student drop off congestion and safety is being addressed through the planned bus area between the three school sites.
- 2. Informal / Small Group Learning Spaces:** The central core of the school can be reconfigured to provide additional collaboration spaces. This would be accomplished by reconfiguring the existing E.I. Dramatic Play room, Classroom 138, and Library and creating an interconnected learning commons with associated break out spaces, small counselling areas, and alcoves where small group learning could take place.
- 3. Natural Lighting:** The existing windows in the South classrooms could be replaced and enlarged to introduce additional natural light and ventilation.
- 4. Community Use:** Additional lock-off points can be introduced to provide better security during after hours community use.

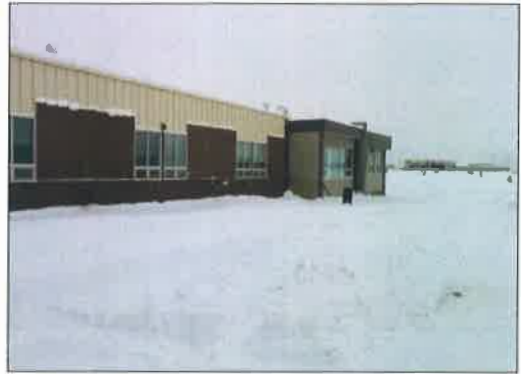
Supervision and lighting level is an issue on the North side of the modular classrooms.

- 2. Site Supervision:** Site supervision is an issue along the North side of the modular classrooms. Lighting also needs to be improved on both sides of the North modulares and at the staff parking area.

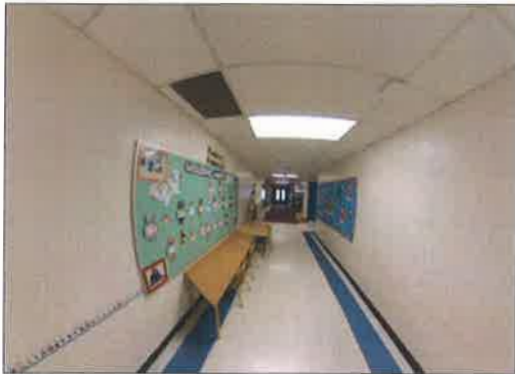
The lack of pull out spaces requires that desks and teaching locations are in offices, the library, staff room, and corridors.

- 3. Site Drainage:** There is pooling at the South modulares with lots of ice at the entrances.
- 4. Informal / Small Group Learning Spaces:** There is a deficiency of break out and counselling spaces for smaller group work. Classrooms and the staff room are being used for pull out space.

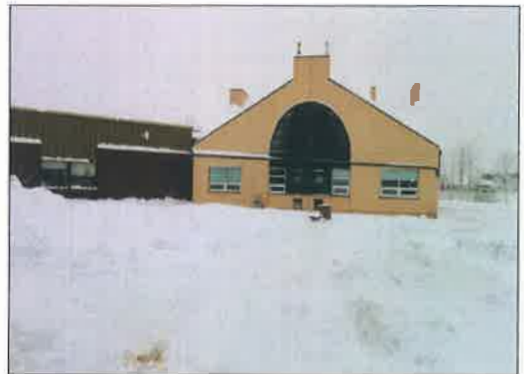
Pooling occurs on the site at the South moduls during spring thaw. Lighting levels should also be improved in this area.

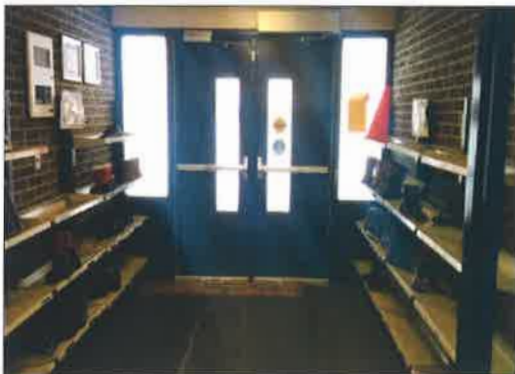
The front entrance can see considerable congestion due to EI and ECS students using it for exiting.

- 9. Main Entrance:** EI and ECS students use the main entrance to the school which causes congestion on entering the school.
- 10. Washroom Fixtures:**
existing school: 14 male / 15 female
code requirement: 9 male / 11 female

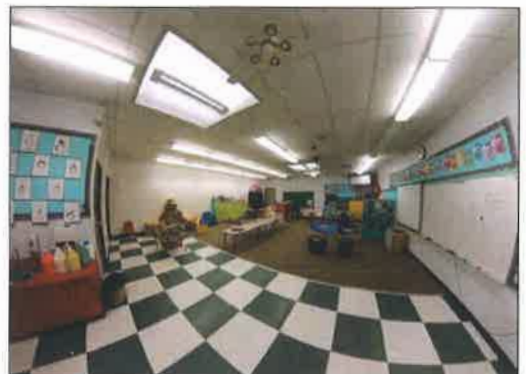
The school has a large central core of instructional spaces with no natural lighting or ventilation.

- 8. Natural Light / Ventilation:** The planning of the school has a large central core of instructional spaces and the lack of natural light in these areas was noted. It was also noted that the classrooms along the South side of the school have small windows that have failed are dirty between the glass panes.

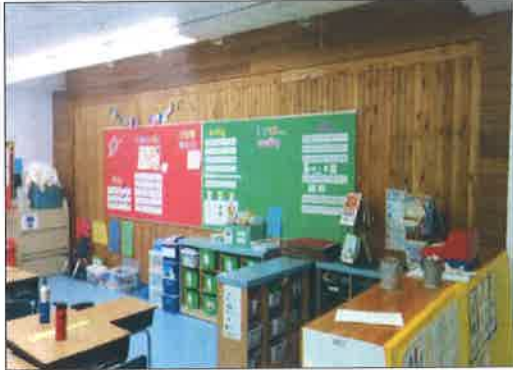
Noise transfer is an issue between classrooms 105 and 102 due to the stage opening being infilled.

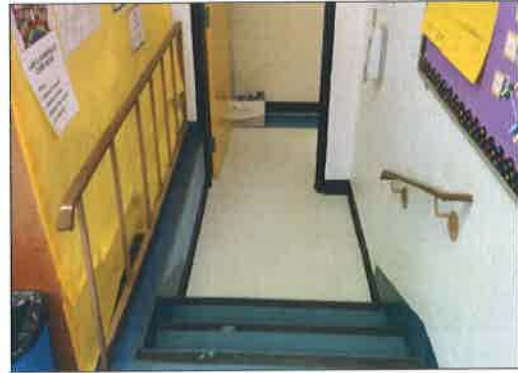
Accessibility to classroom 105 is an issue due to the space being the former stage.

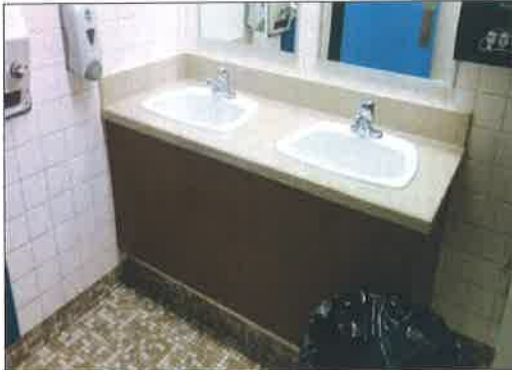
Upgrades are required in the washrooms to meet current barrier-free guidelines.

- 6. Barrier-Free Accessibility:** Upgrades are required to the sinks and stalls in the washrooms to meet current accessibility guidelines.

Provide a gymnasium divider curtain to improve flexibility in programming for students.
- 2. Barrier-Free Accessibility:** Upgrade washrooms to meet current accessibility guidelines.
- 3. Informal / Small Group Learning Spaces:** Informal and small group gathering spaces are required in the school to accommodate a variety of learning group sizes.
- 4. Administration Area:** Work is underway to reconfigure parts of the administration area to incorporate a special needs washroom.

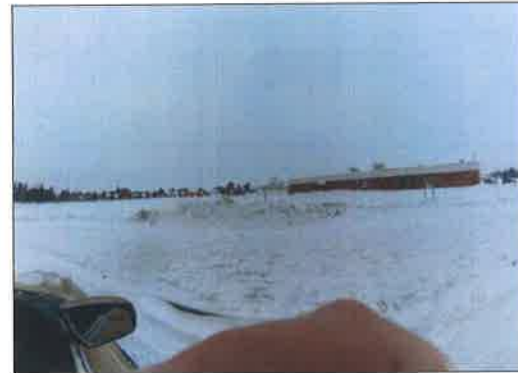
A request for funding has been made to expand the play area. It was noted that the play structures are not well suited to high needs students.

The play structures are congested due to the number of students. Funding has been made for additional play structures. Currently the congestion is addressed by scheduling.

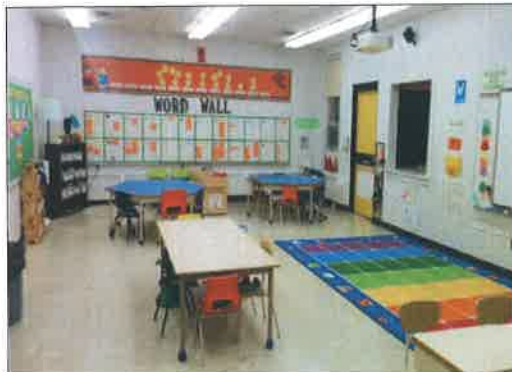
There is a lack of break out spaces and small group work areas. An existing classroom is used to provide areas.

- 7. Informal / Small Group Learning Spaces:** The school lacks break out spaces for learning in various group sizes.

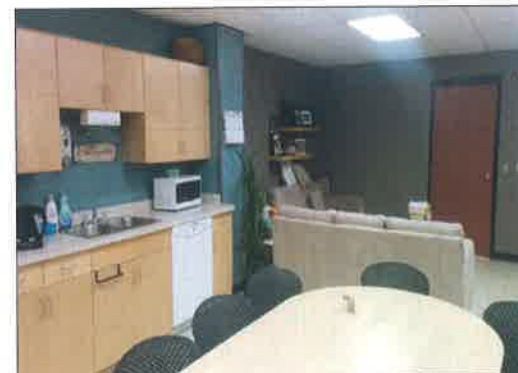
There is a deficiency of administration space with a lack of conference and counselling spaces.

There is a deficiency in administration spaces, specifically staff washrooms, conference room, and counselling areas.
